# BALTIMORE CITY MS4 ANNUAL REPORT

Reporting Period: July 1, 2014 to June 30, 2015

DEPARTMENT OF PUBLIC WORKS  
RUDOLPH S. CHOW, P. E.  
DIRECTOR

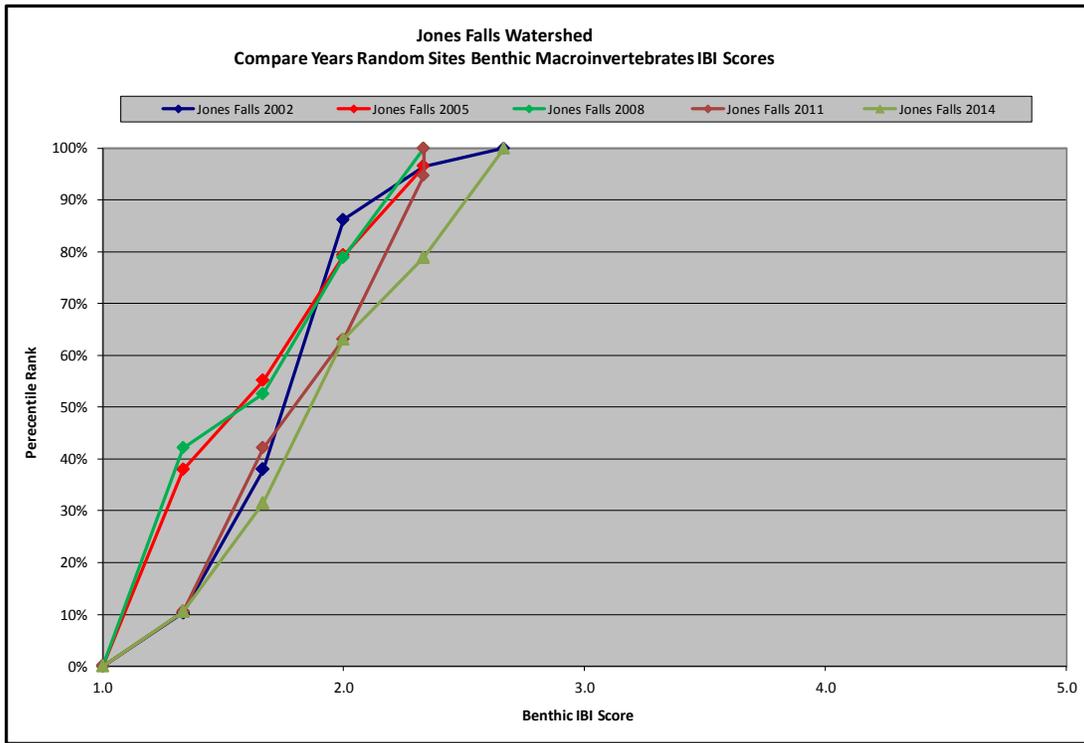
There were 20 random stations sampled in the Jones Falls watershed in 2014. There were 12 samples with BIBI scores from 1.0 through 1.7, which rated as “very poor”; and 8 samples with BIBI scores from 2.0 through 2.7, which rated as “poor”. Random sampling was performed in the Jones Falls watershed in 2002, 2005, 2008, 2011 and 2014. Figure 1 illustrates the distribution of the BIBI scores for each of those five (5) years. The curve representing the distribution of the 2014 samples stands out as the best of the five (5) years.

**Figure 1: BIBI Scores for Macroinvertebrate Samples Random Sampling in the Jones Falls Watershed**

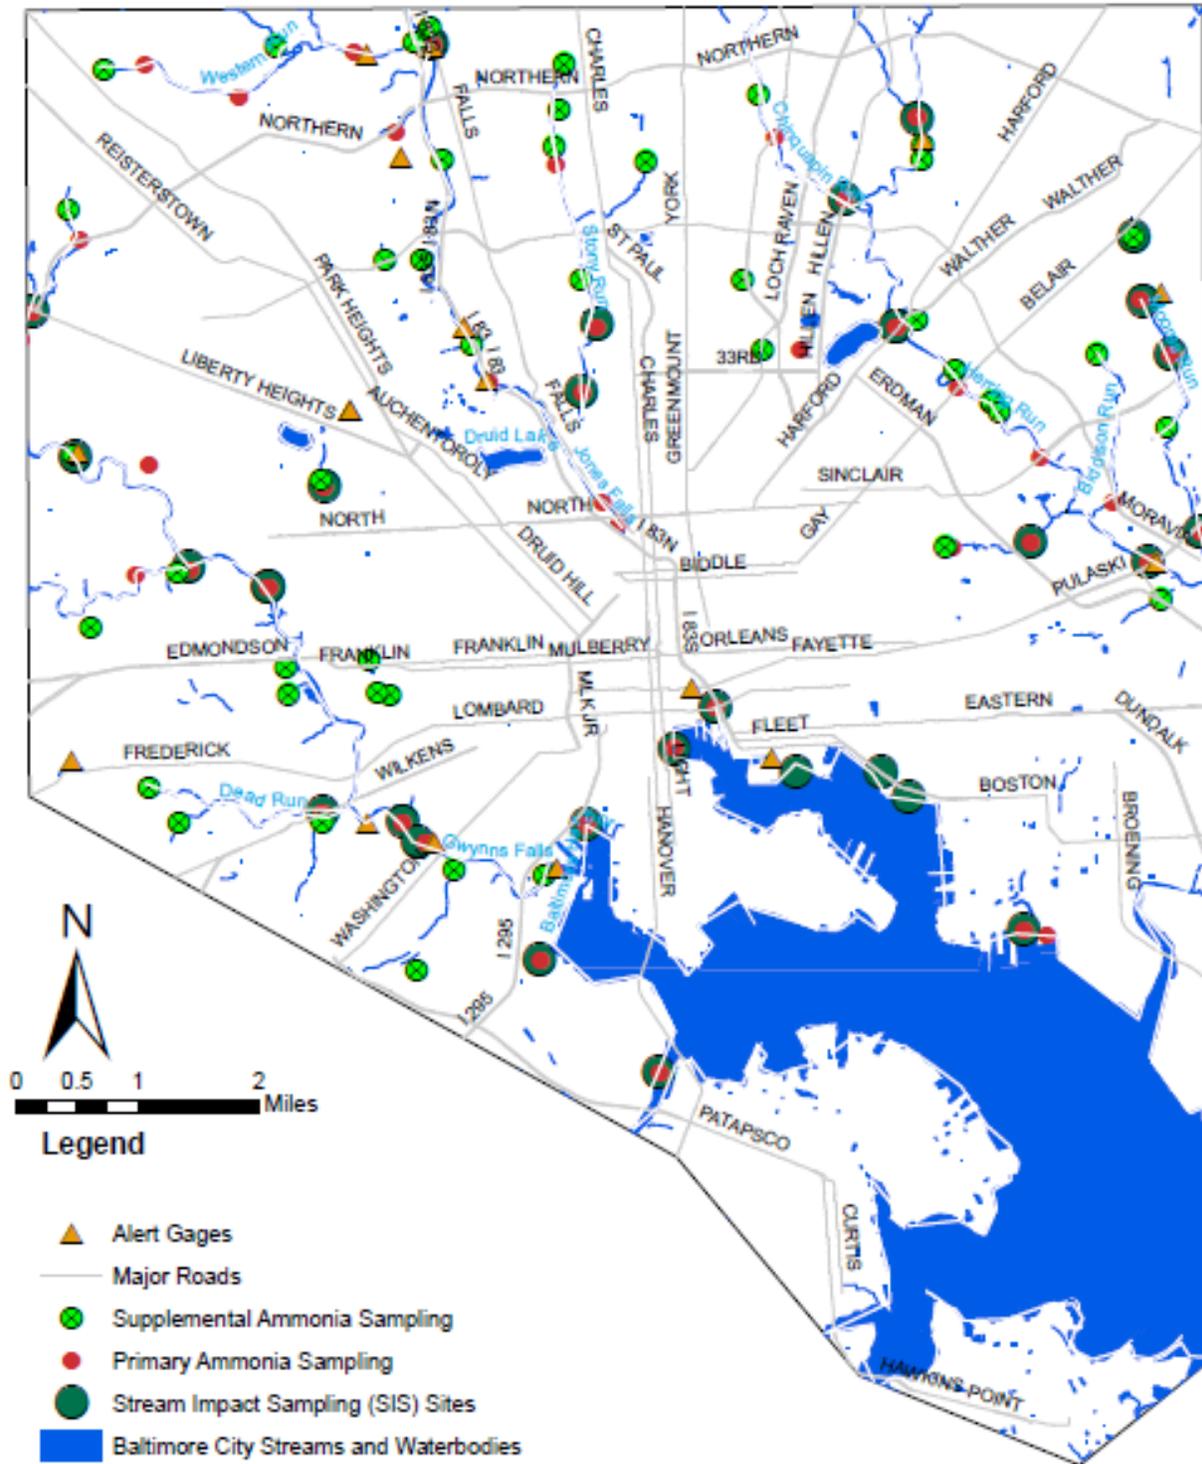
DPW relies on ammonia screening (AS) and stream impact sampling (SIS) to initiate pollution source tracking (PST) investigations. DPW has utilized this alternative method of IDDE since 1998, which allows a routine (weekly) field analysis of 45 outfalls in the City as part of the AS program. In FY 2015, DPW added 43 supplemental AS locations, which are sampled on a monthly frequency. The geographic distribution of AS and SIS sampling locations is shown in Figure 2, with geo-reference data provided in Appendix B. The monitoring results from the surveys for the AS and SIS programs for FY 2015 are included in Appendix C of this report. These monitoring results, plus historic data, are also available online at the Cleanwater Baltimore website.

**Figure 2:** Sampling Locations for the Ammonia Screening (AS) and Stream Impact Sampling (SIS)

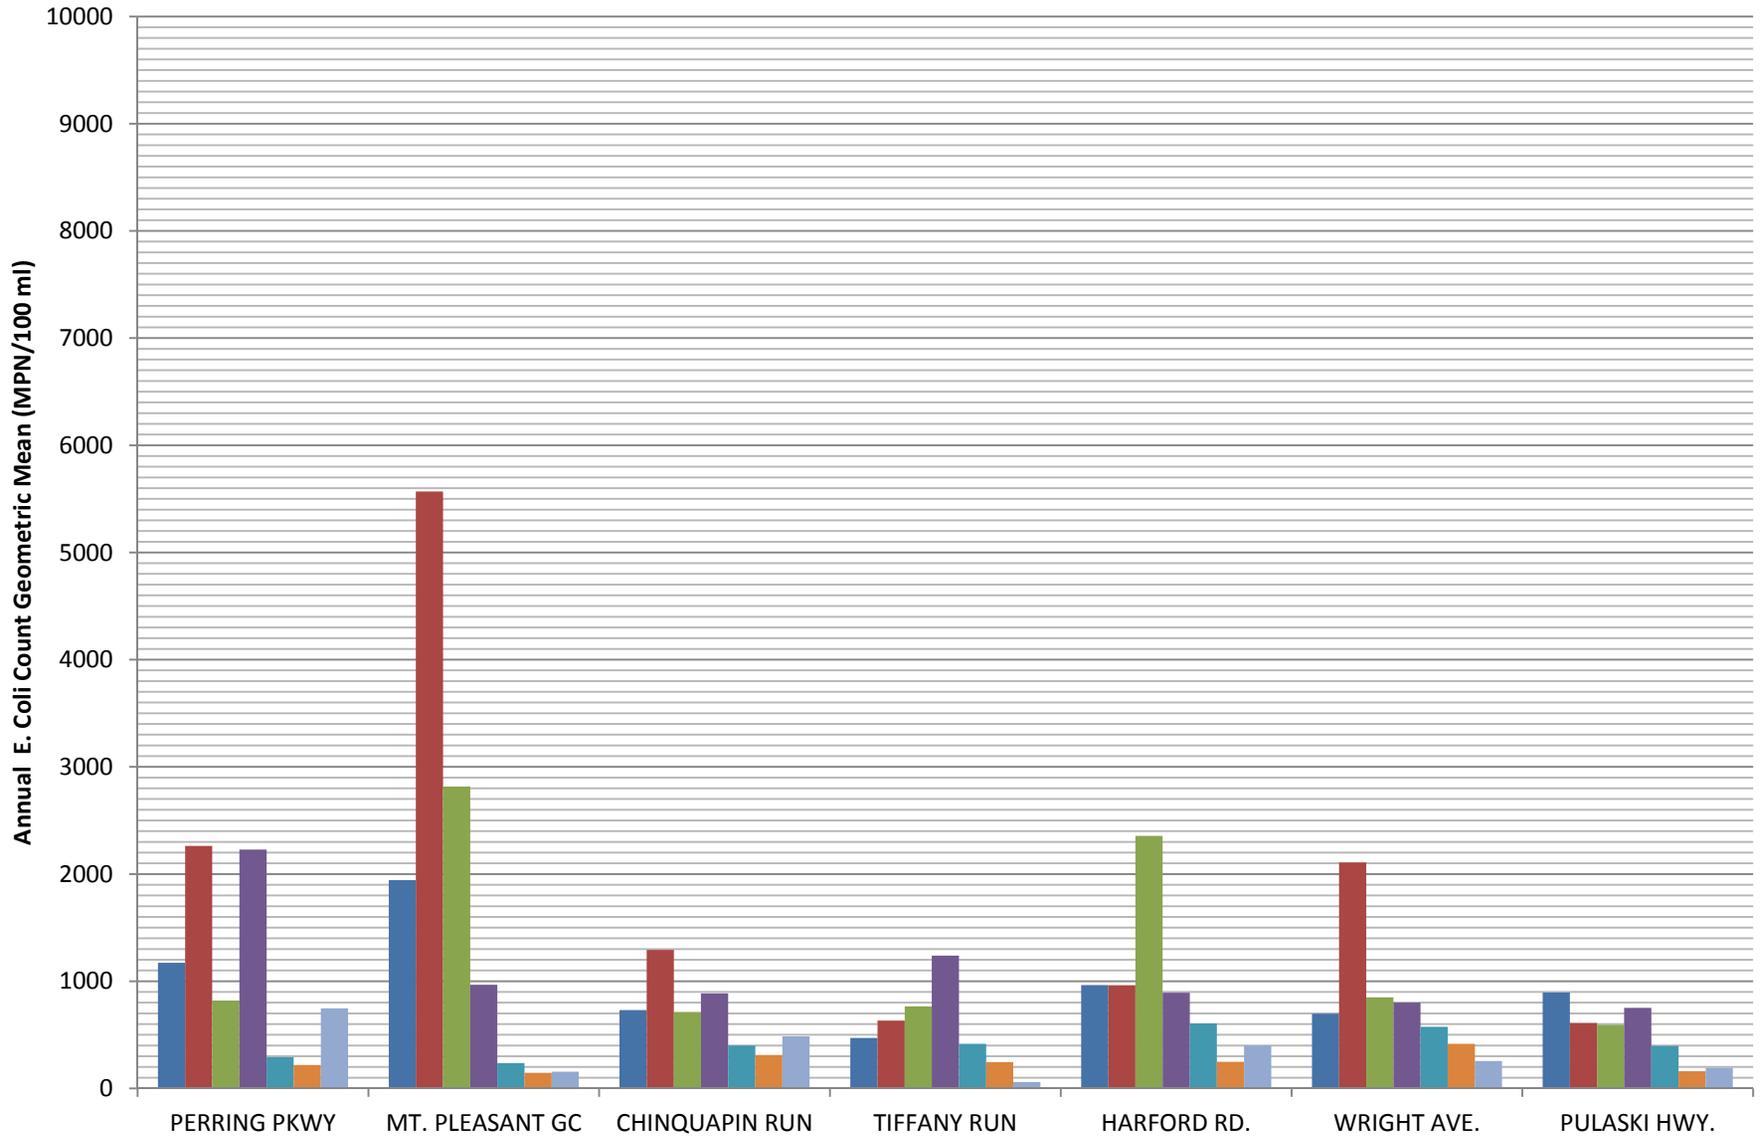
# Herring Run SIS E. Coli MPN Count Geometric Means by Year by Station

2009 2010 2011 2012 2013 2014 2015 (through 11/13/2015)

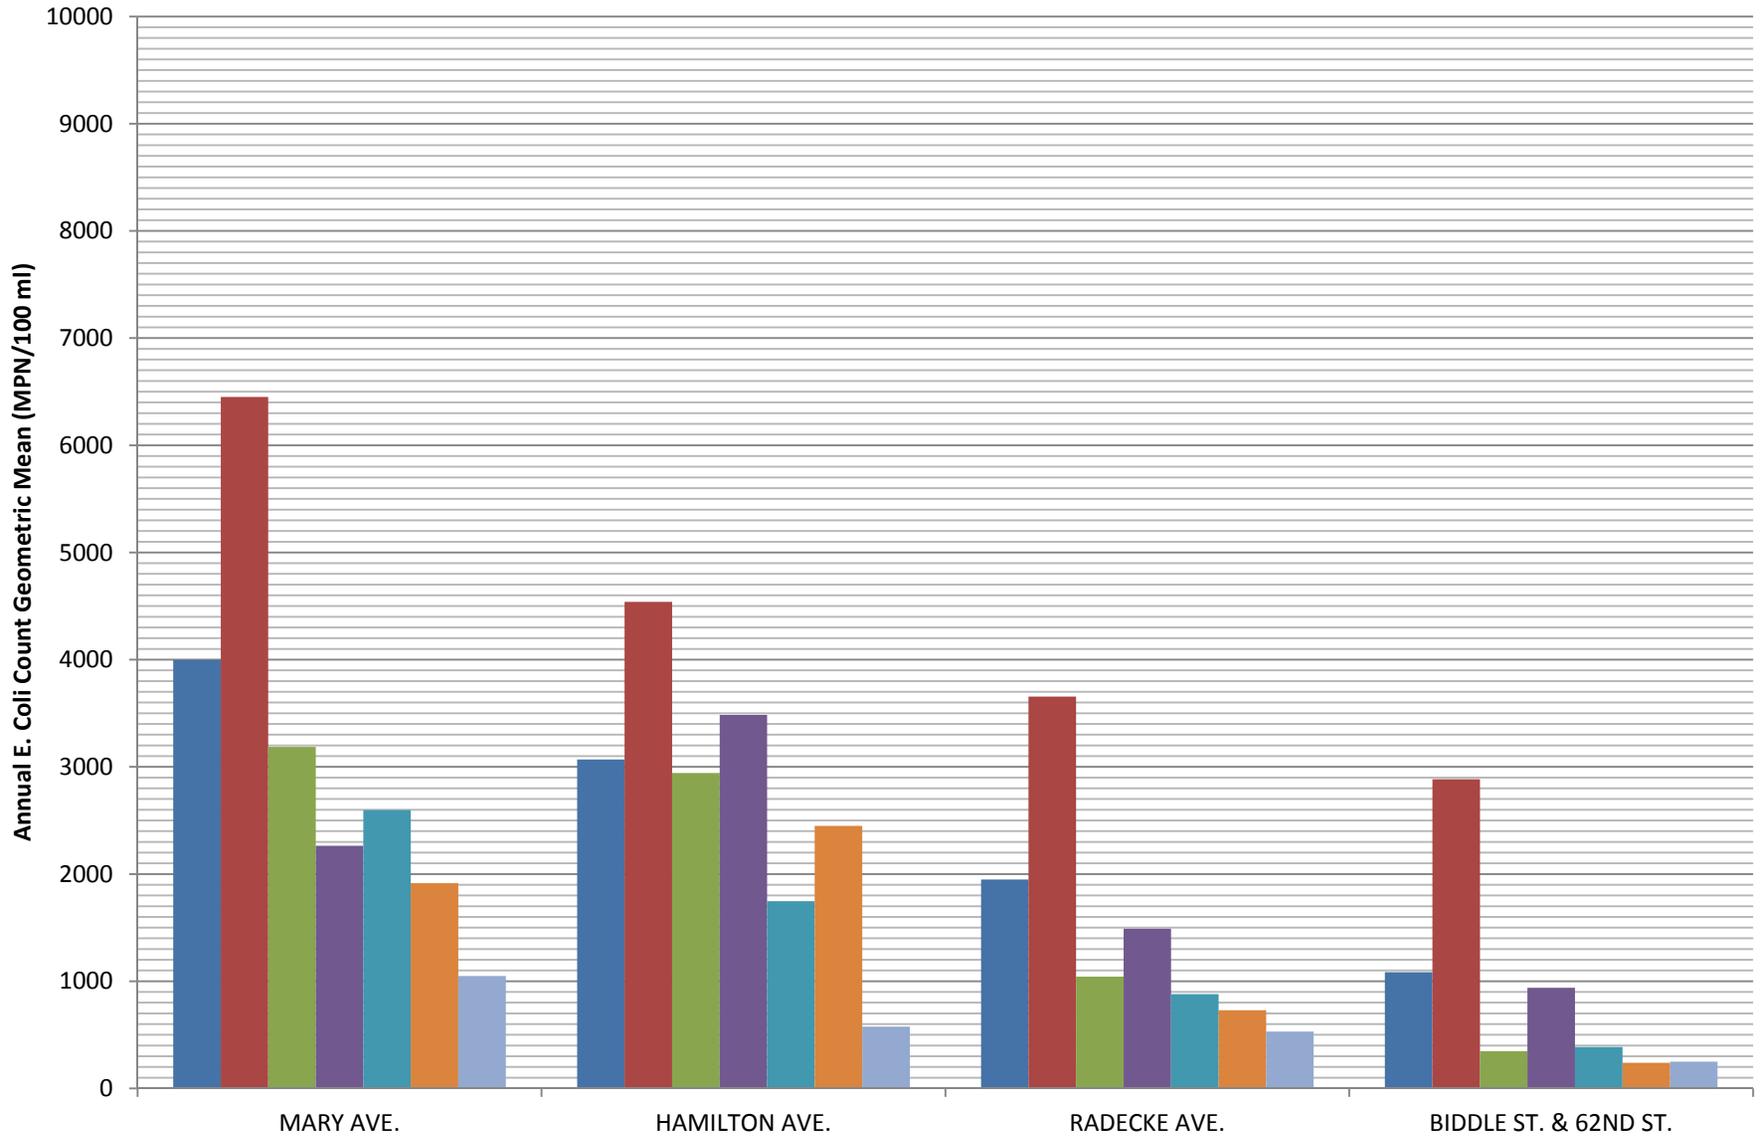
# Moores Run SIS E. Coli MPN Count Geometric Means by Year by Station

■ 2009 ■ 2010 ■ 2011 ■ 2012 ■ 2013 ■ 2014 ■ 2015 (through 11/13/2015)

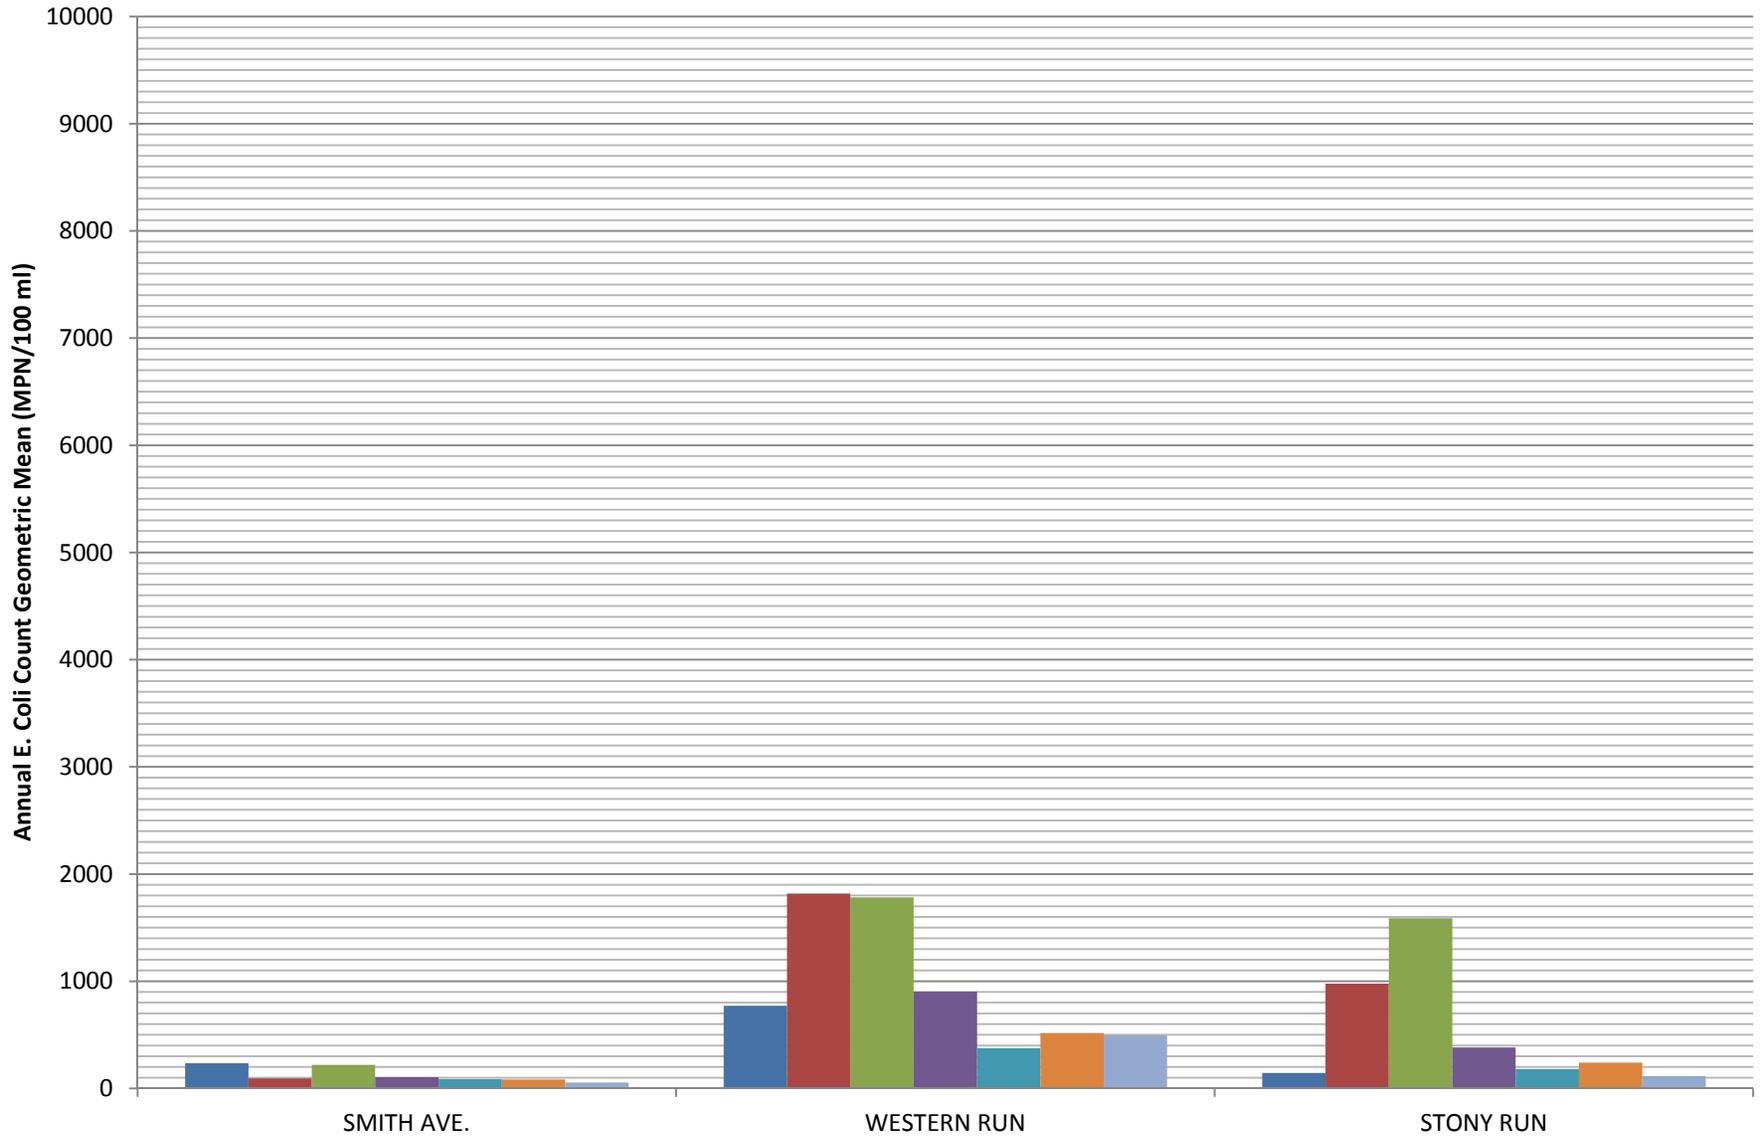
# Jones Falls SIS E. Coli MPN Count Geometric Means by Year by Station

■ 2009 ■ 2010 ■ 2011 ■ 2012 ■ 2013 ■ 2014 ■ 2015 (through 11/13/2015)

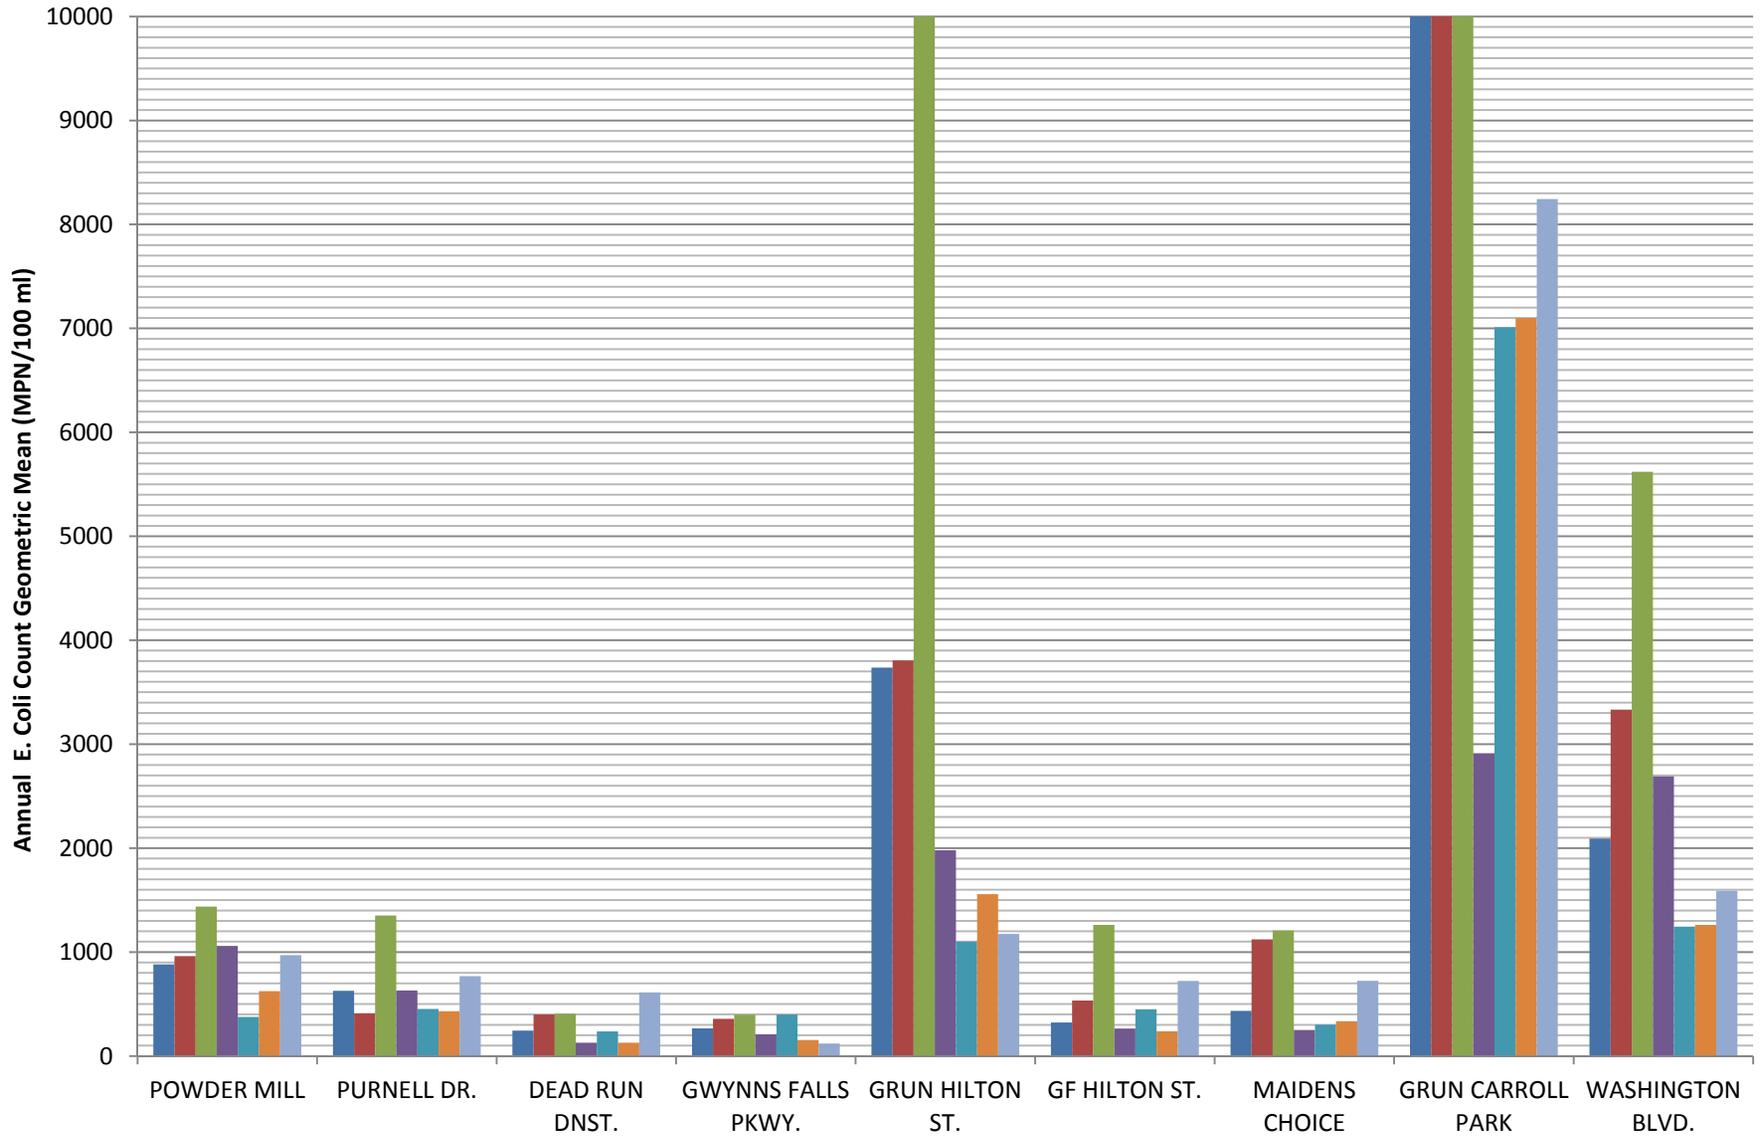
# Gwynns Falls SIS E. Coli MPN Count Geometric Means by Year by Station

■ 2009 
 ■ 2010 
 ■ 2011 
 ■ 2012 
 ■ 2013 
 ■ 2014 
 ■ 2015 (through 11/13/2015)

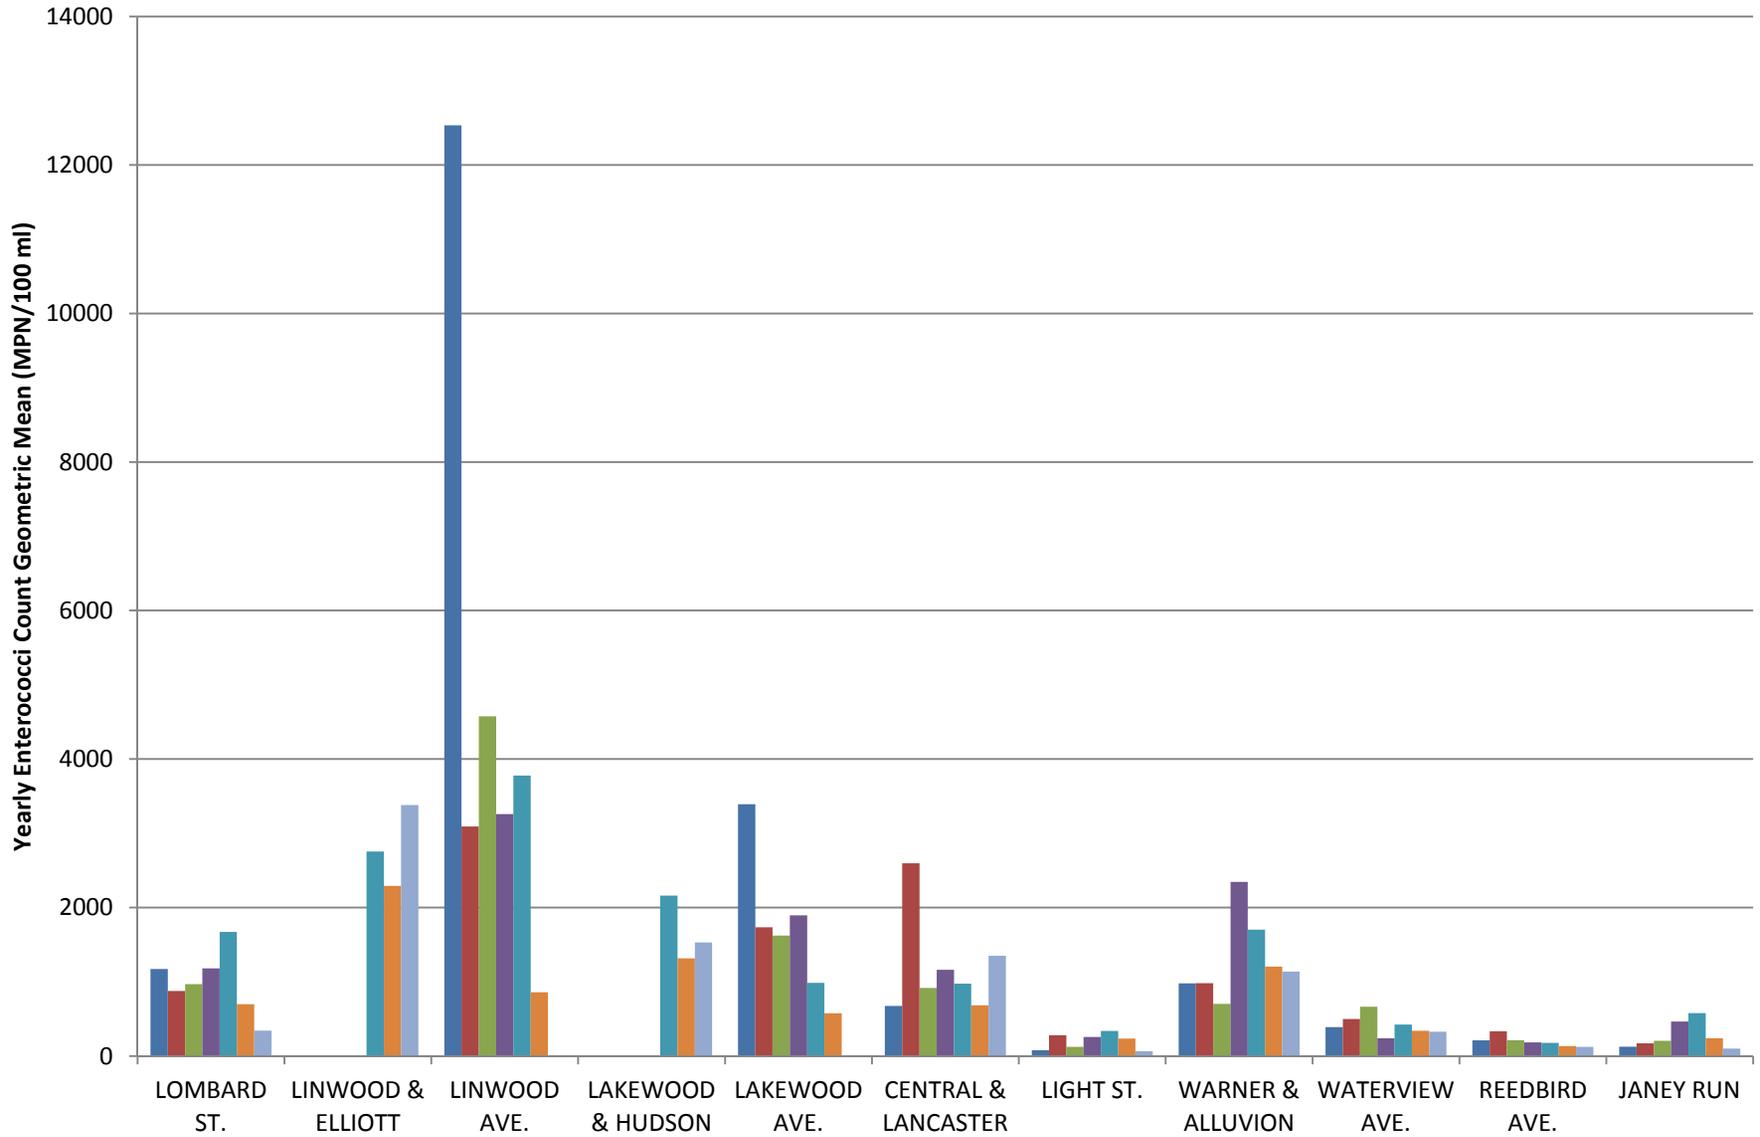
# Harbor SIS Enterococci MPN Count Geometric Means by Year by Station

■ 2009 
 ■ 2010 
 ■ 2011 
 ■ 2012 
 ■ 2013 
 ■ 2014 
 ■ 2015 (through 11/13/2015)
